## **Expanded Site Inspection Report**

CERCLA Expanded Site Inspection Report

Eagle Zinc Company

Ild. 980606941

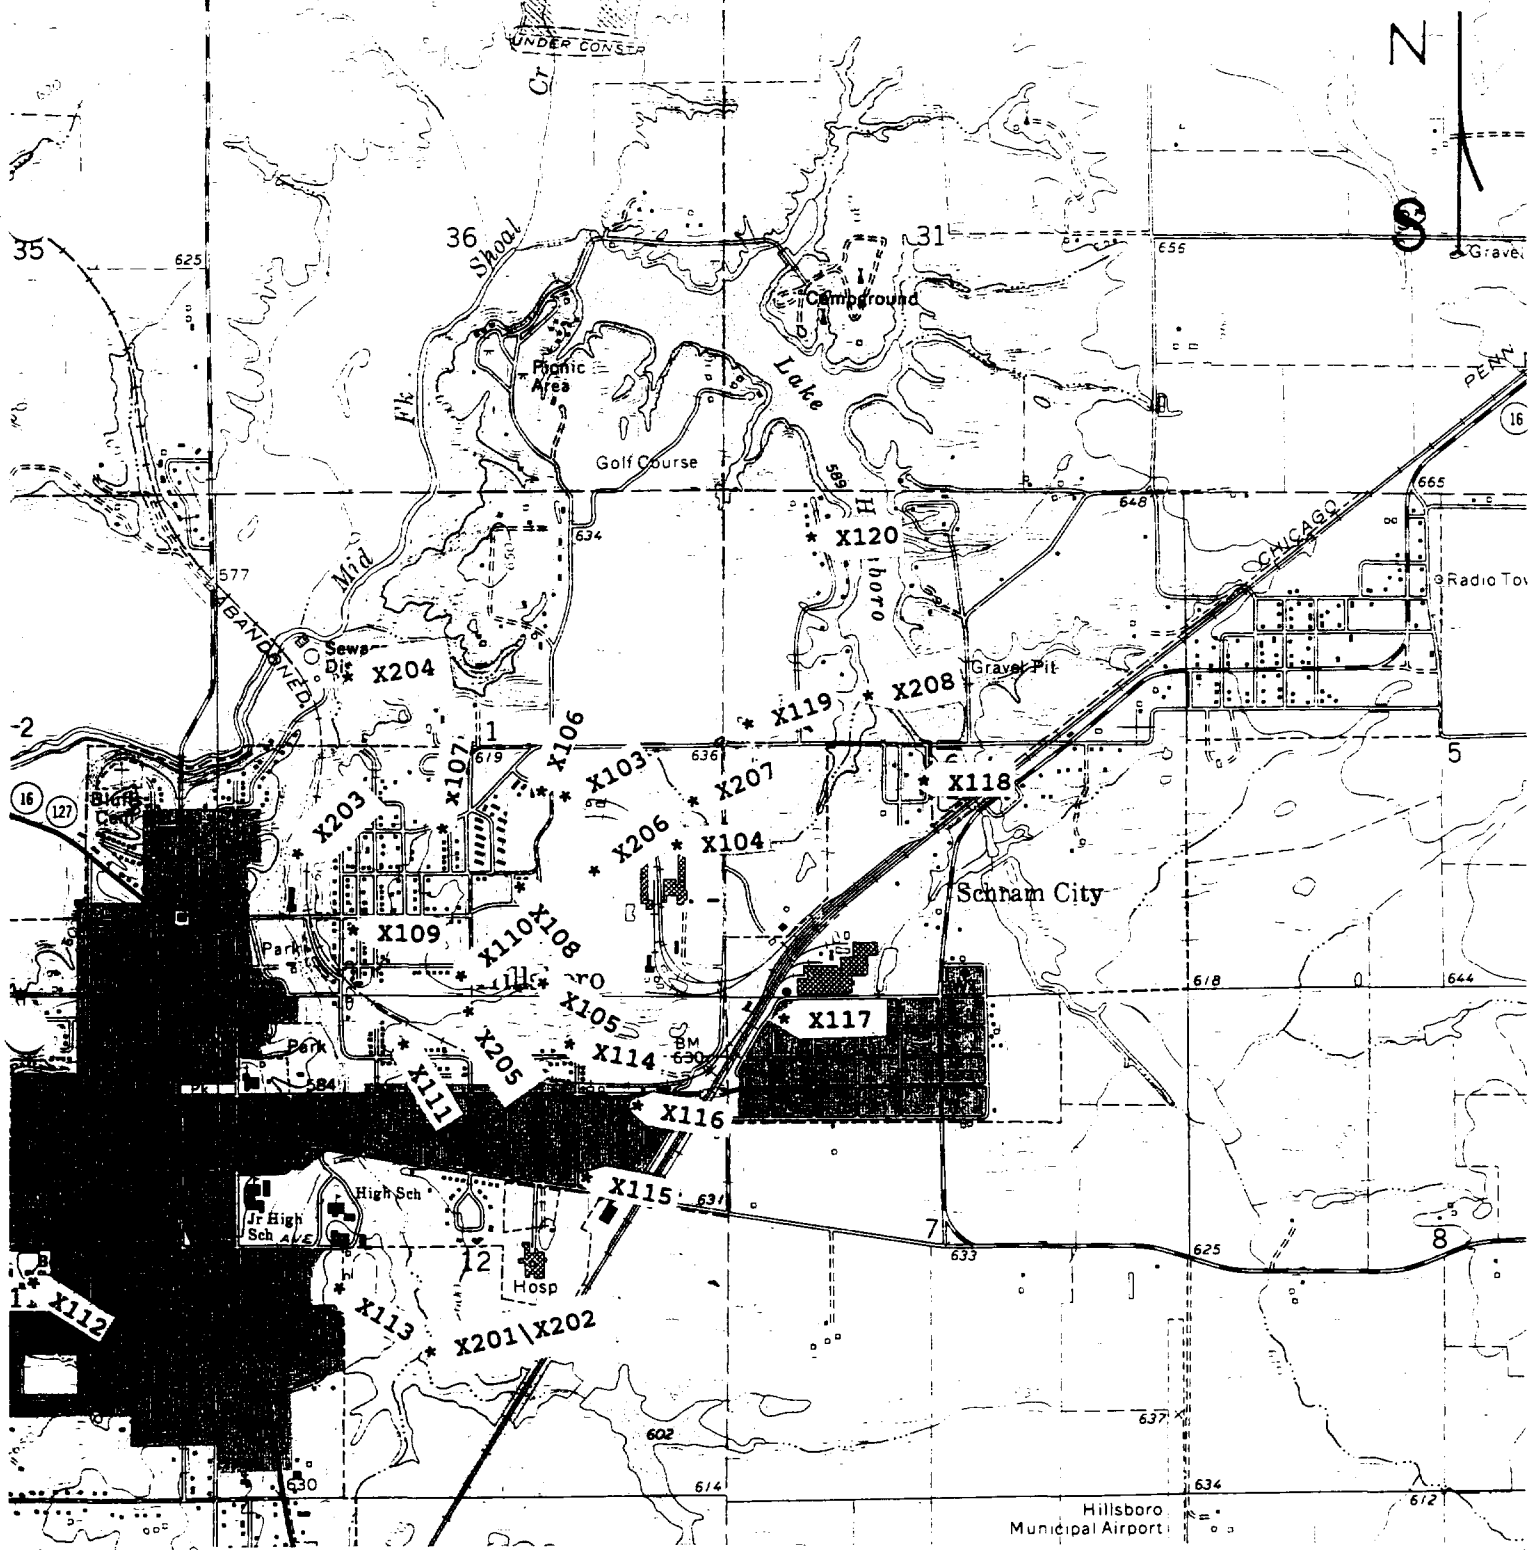
# SAMPLING LOCATION MAP

Samples X103, X104, and X105 were collected within the boundaries of the facility. X103 and X105 were sampled from residue piles on the property (Figure 3-2). X104 was a soil sample taken north of the Zebra building (Figure 3-2). All facility samples were collected within the top four inches using a stainless steel trowel.

The remaining soil samples were collected from residential properties surrounding the Eagle Zinc Company property. Samples of soil were collected from residential yards and within 200 feet of the homes. Each sample located on Figure 3-2 was collected with a stainless steel trowel at 0-4 inches in depth. Soil sample appearance and sampler comments were recorded in a field log book. Measurements of where the sample was collected in relation to the residence were also recorded.

Samples X201, and duplicate sample X202, were collected from the intermittent stream west of Eagle Zinc (Figure 3-2). These two samples served to provide background concentration information for all sediment samples collected during the Expanded Site Inspection. Samples X201 and X202, were located upstream of X203 and therefore believed not to be affected by surface drainage from the Eagle Zinc property. The sample was taken from the west bank of the stream at the confluence of the two intermittent streams. Sediments were collected from approximately zero to four inches by use of a stainless steel trowel. Prior to collecting this sample, sediments were placed in a stainless steel tray and mixed thoroughly using a trowel.

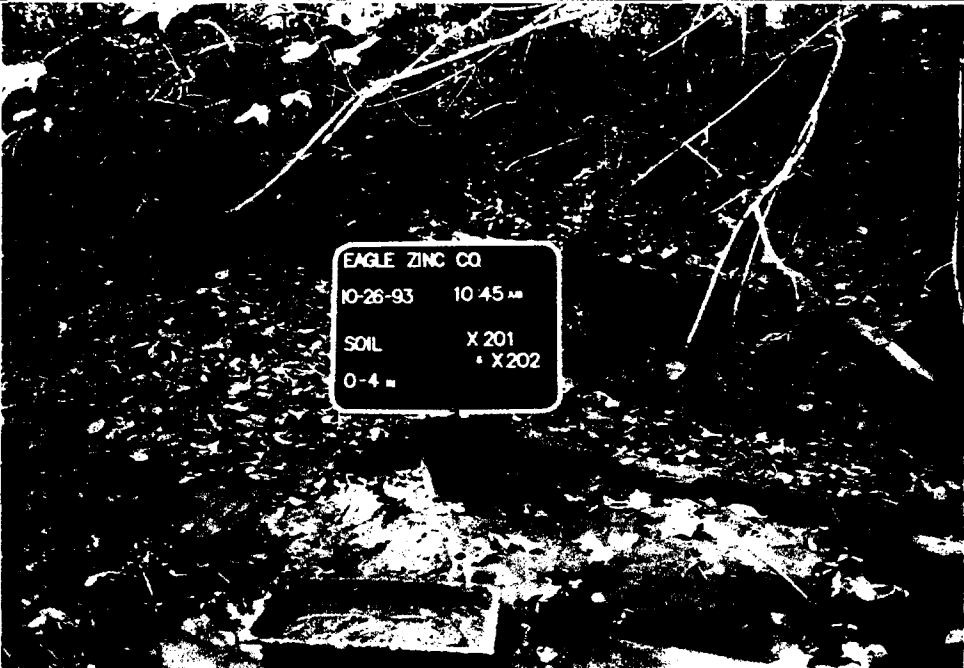
COMMENTS: Picture taken toward: WEST	
Sample X201\X202	
(DUP. of X201)	
Background sediment sample.	
Roll 1, Photo 7	
Depth 0-4 in

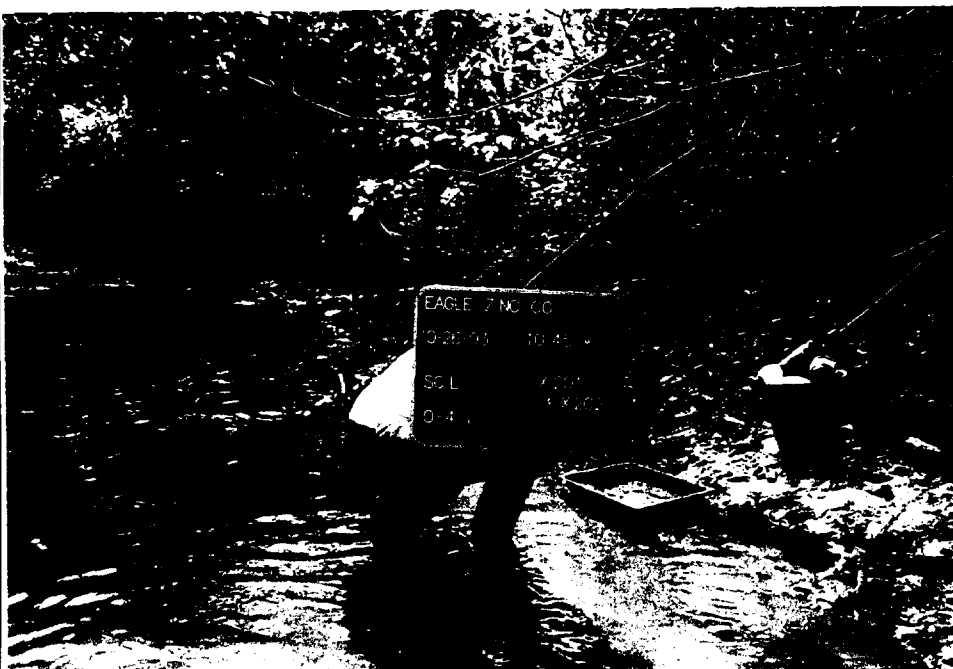
DATE: 10/26/93
TIME: 10:45 A
PHOTOGRAPH TAKEN BY: BRUCE EVERETTS
COMMENTS: Picture taken toward: SOUTH
SAMPLE X201\X202
(DUP. of X201).
Background sediment sample.
Depth 0-4 in
Roll 1, Photo 8

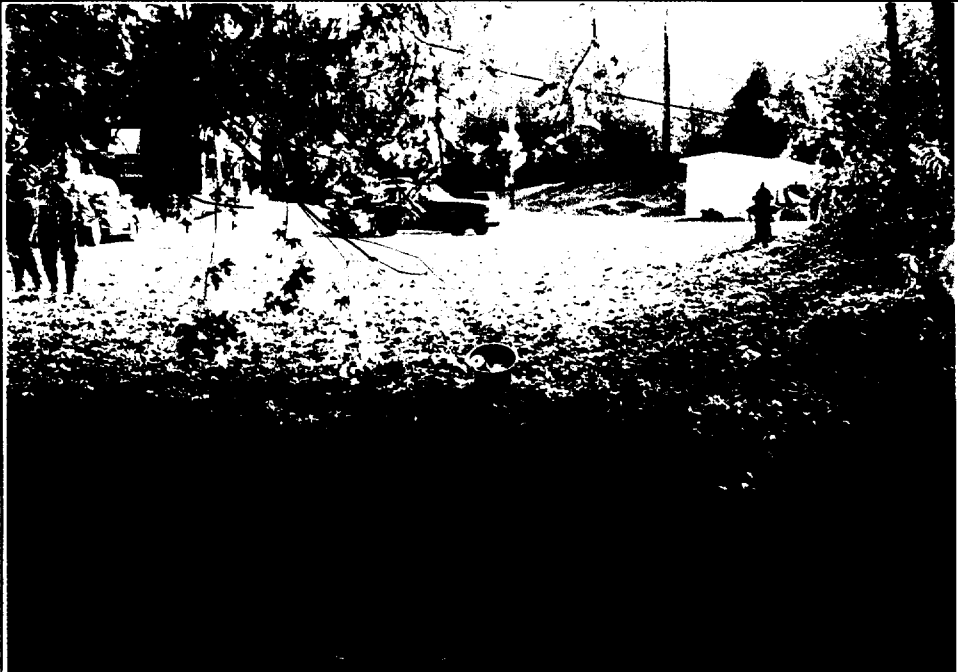
COMMENTS: Picture taken toward: NORTHEAST	
SAMPLE X203	
Sediment sample.	
Hillsboro Water	
Plant in the back- ground.	
Roll 1, Photo 5	
Depth 0-4 in

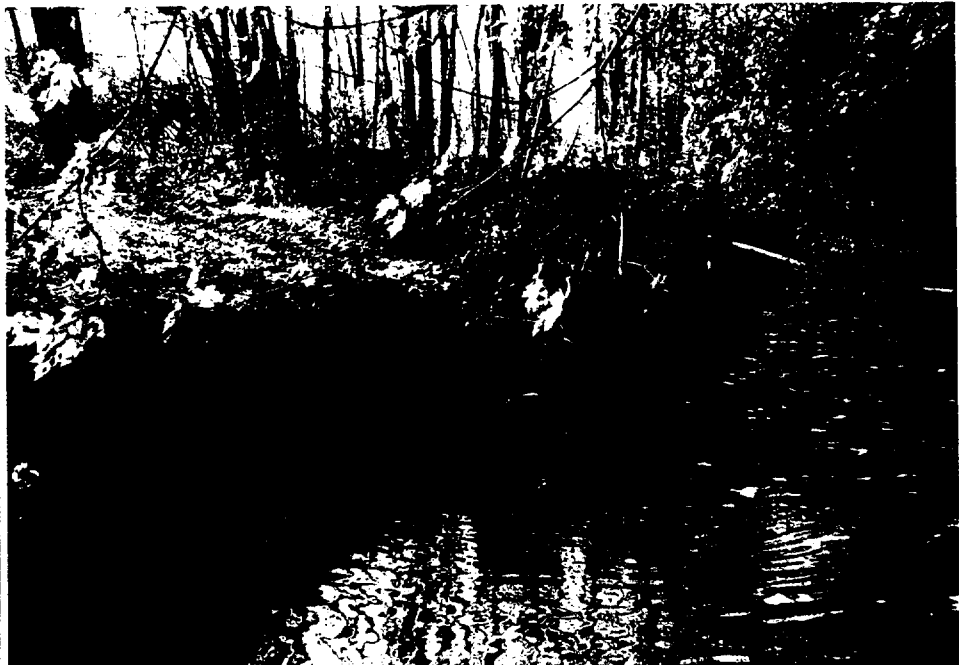
DATE: 10/26/93
TIME: 9:50 A
PHOTOGRAPH TAKEN BY: MARK WAGNER
COMMENTS: Picture taken toward: SOUTH
SAMPLE X203
Sediment sample.
Depth 0-4 in
Roll 1, Photo 6

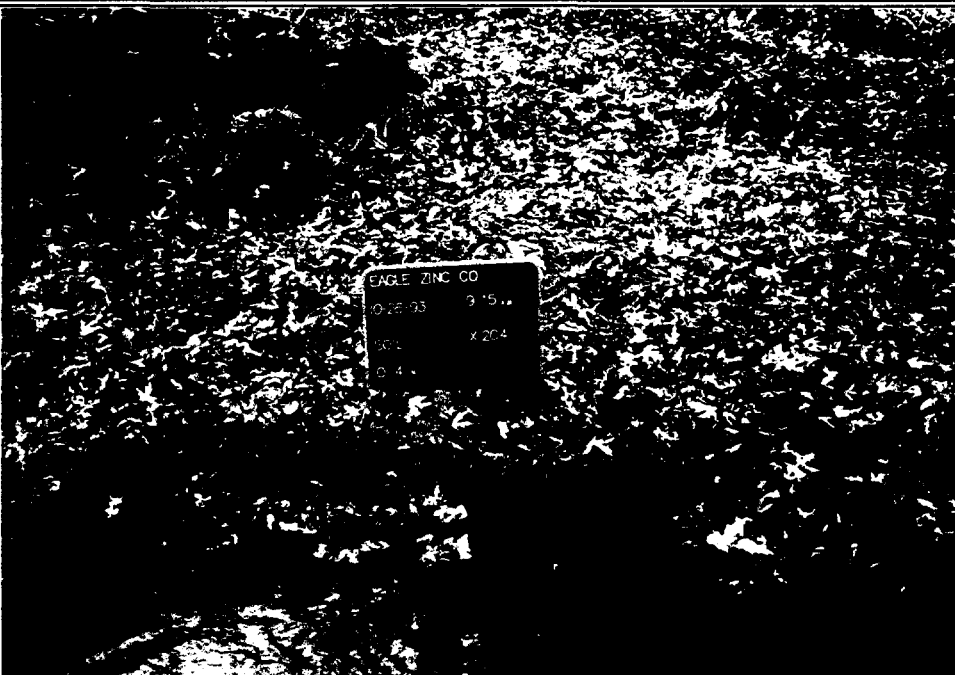
COMMENTS: Picture taken toward: SOUTHEAST	
Sample X 204	
Sediment sample.	
Depth 0-4 in	
Roll 1, Photo 3

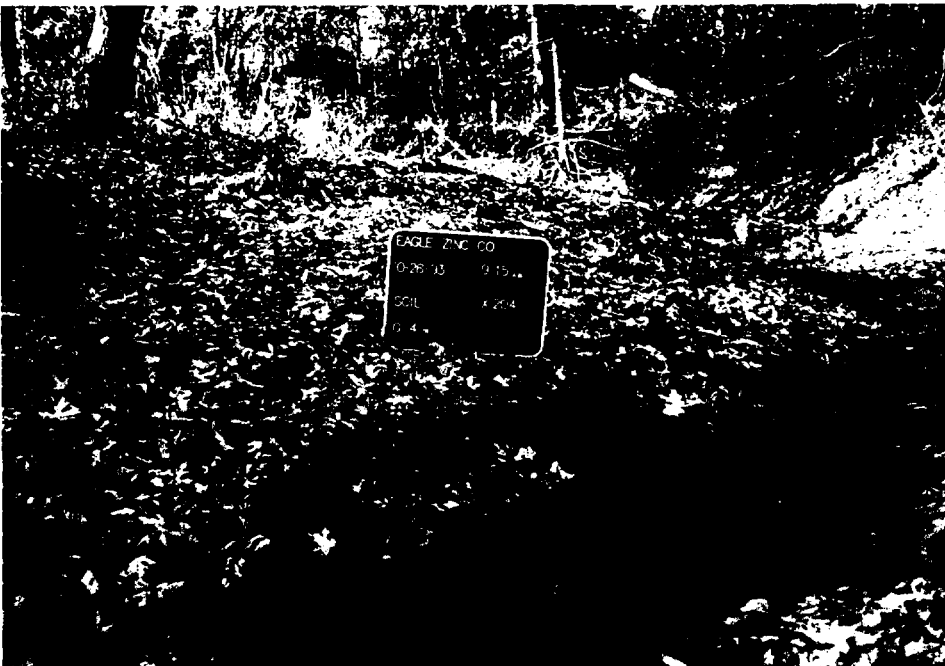
DATE: 10/26/93
TIME: 9:15 A
PHOTOGRAPH TAKEN BY: MARK WAGNER
COMMENTS: Picture taken toward: SOUTH
Sample X 204
Sediment sample.
Depth 0-4 in
Roll 1, Photo 4

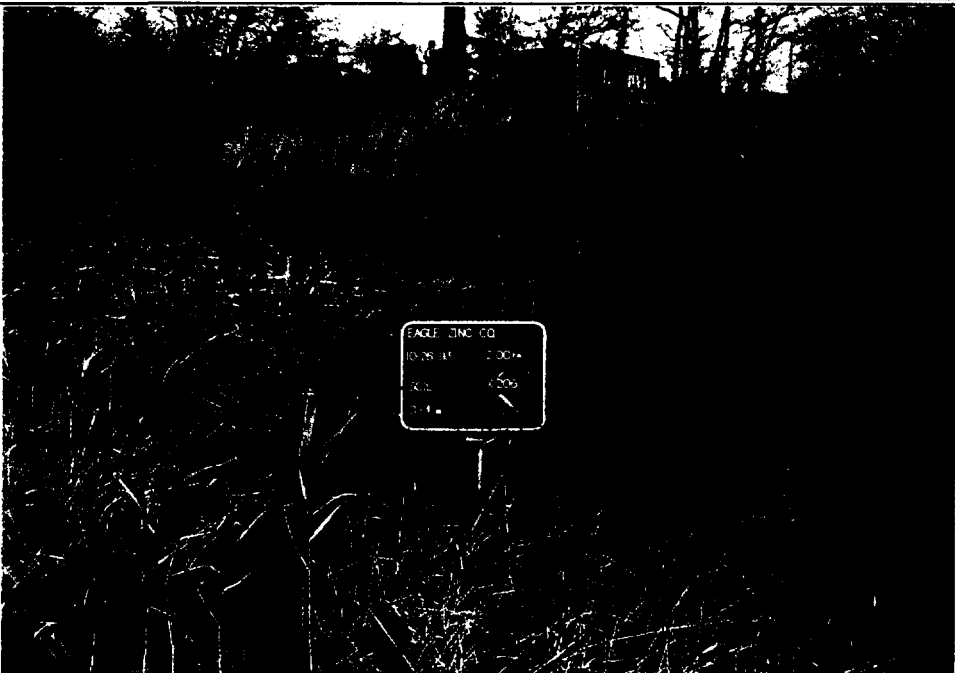
COMMENTS: Picture taken toward: NORTHEAST	
Sample X 206	
Sediment sample.	
Eagle Zinc Co. in the background.	
Depth 0-4 in	
Roll 2, Photo 1

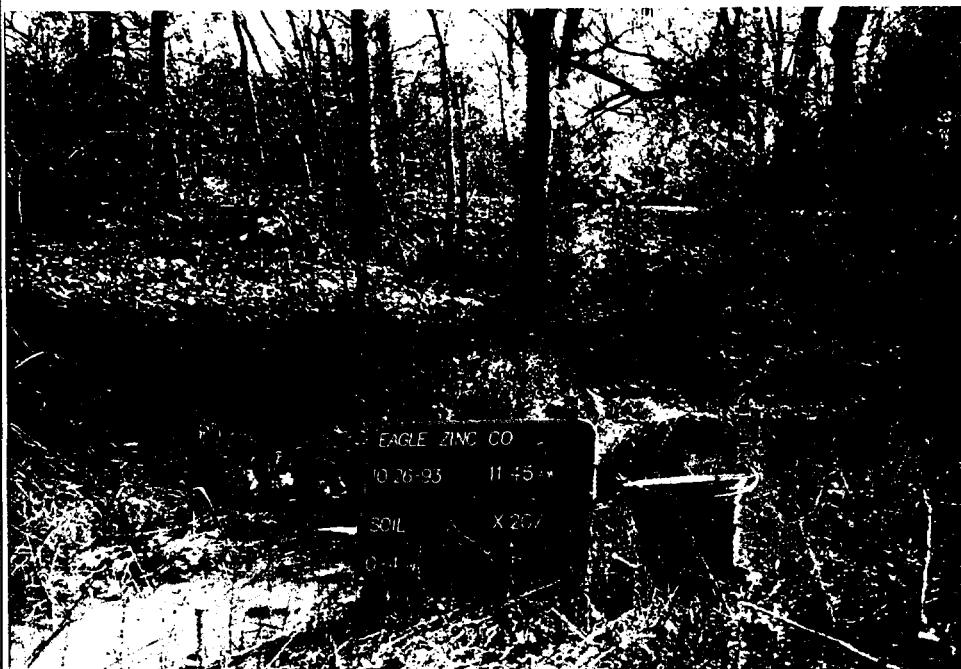
DATE: 10/26/93
TIME: 11:45 A
PHOTOGRAPH TAKEN BY: MARK WAGNER
COMMENTS: Picture taken toward: EAST
Sample X 207
Sediment sample.
Depth 0-4 in
Roll 1, Photo 10

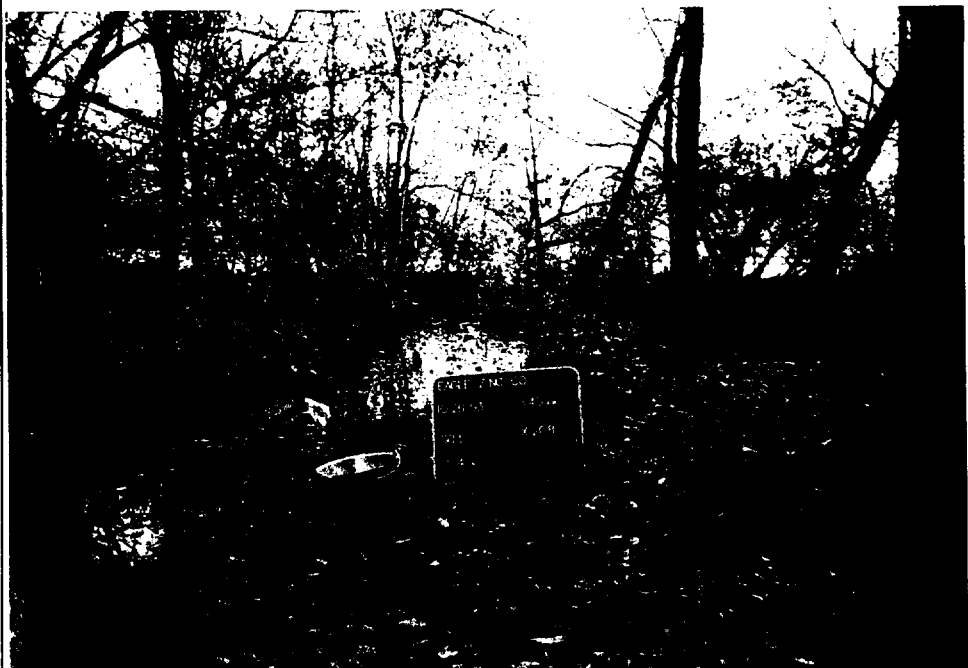
DATE: 10/26/93
TIME: 8:45 A
PHOTOGRAPH TAKEN BY: MARK WAGNER
COMMENTS: Picture taken toward: NORTH
Sample X 208
Sediment sample.
Lake Hillsboro in the background.
Depth 0-4 in
Roll 1, Photo 2

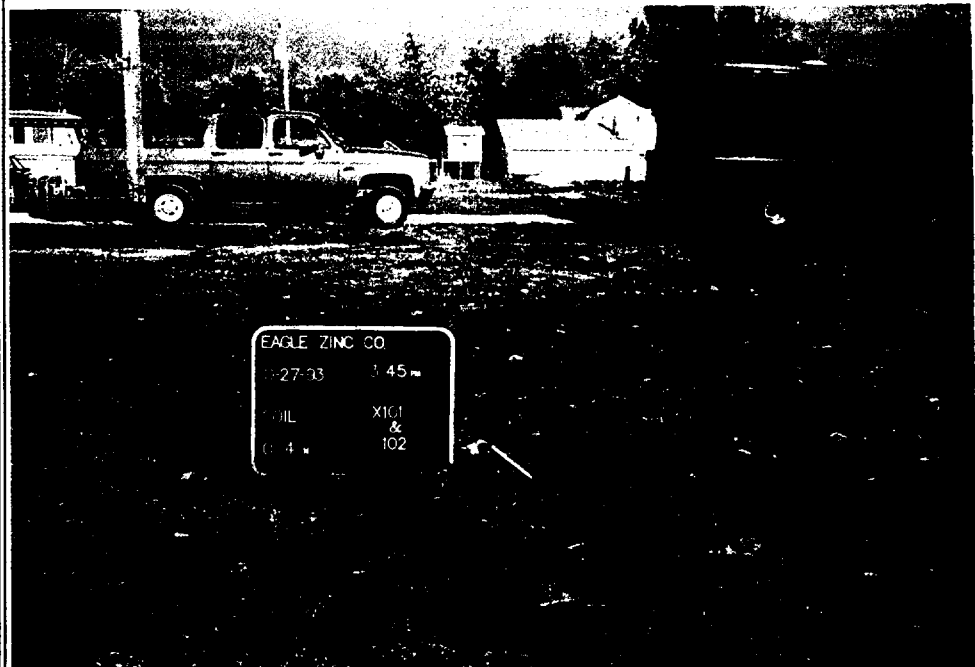
DATE: 10/27/93
TIME: 3:45 P
PHOTOGRAPH TAKEN BY: MARK WAGNER
COMMENTS: Picture taken toward: EAST
Sample X101\X102
(Dup. of X101)
Background soil sample.
Depth 0-4 in
Roll 5, Photo 7

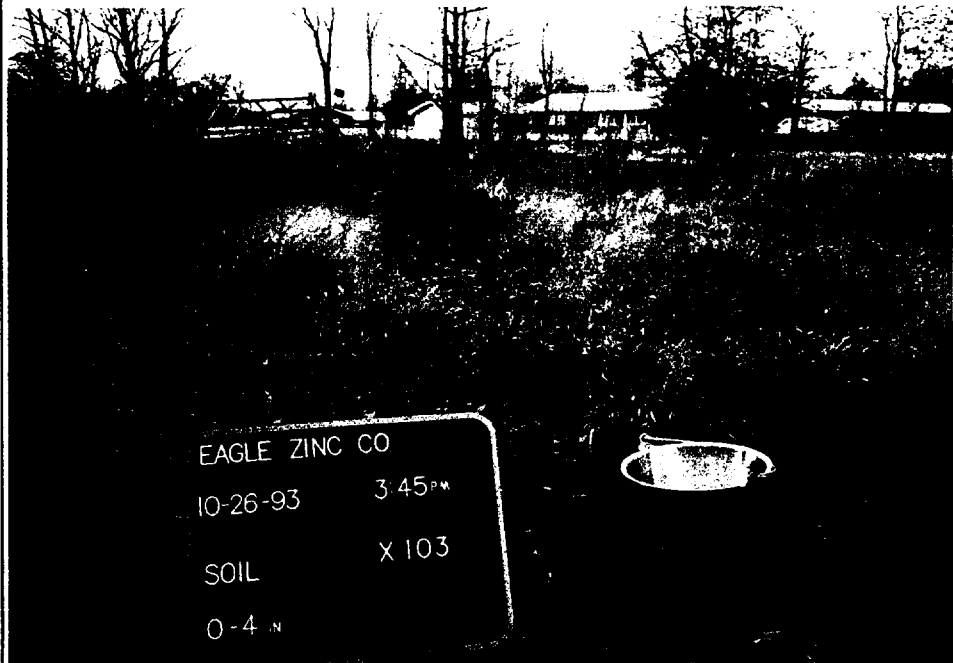
DATE: 10/26/93
TIME: 3:45 P
PHOTOGRAPH TAKEN BY: MARK WAGNER
COMMENTS: Picture taken toward: WEST
Sample X103
Soil sample. Residences in background.
Depth 0-4 in
Roll 2, Photo 10
